Unit 1 Building
Arkansas State Hospital (ASH)

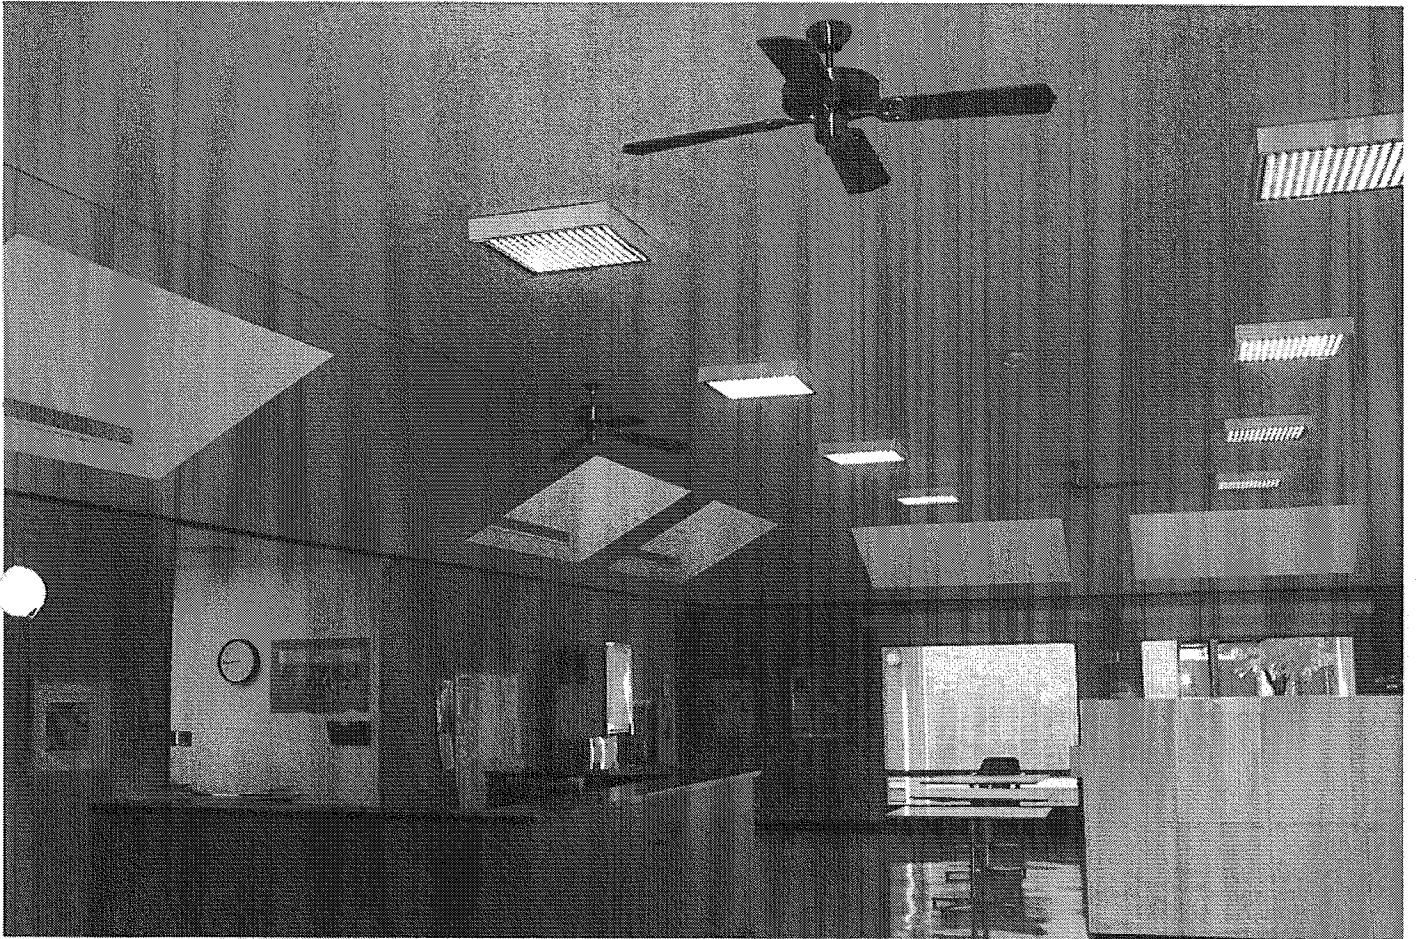
129. Recreational Area - General view of acoustical plaster ceiling

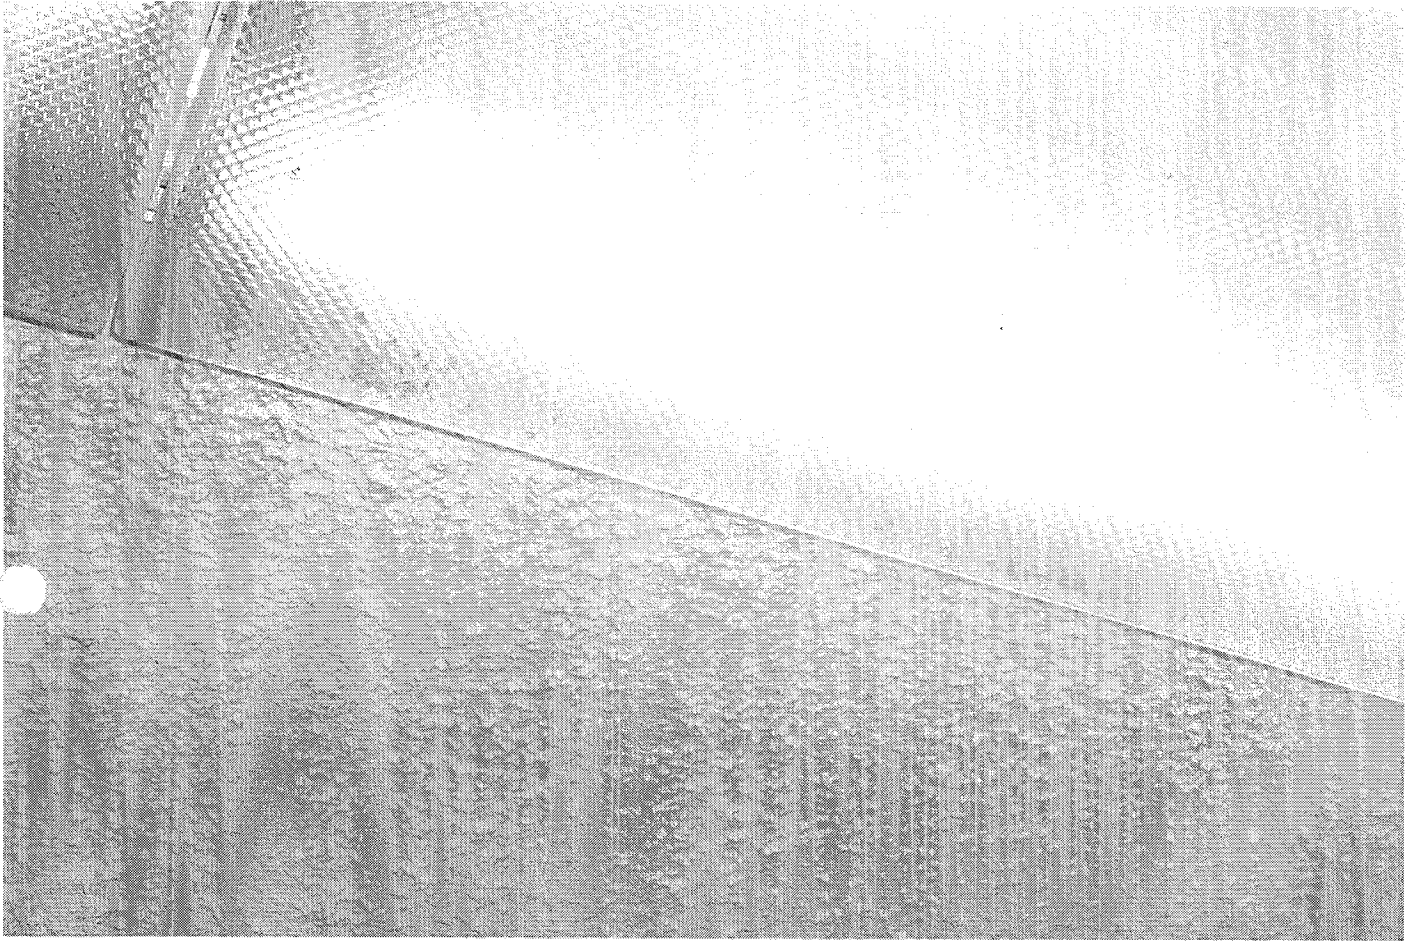
130. Back hallway at office area - Dislodged acoustical plaster debris inside the plastic lens of the light fixture

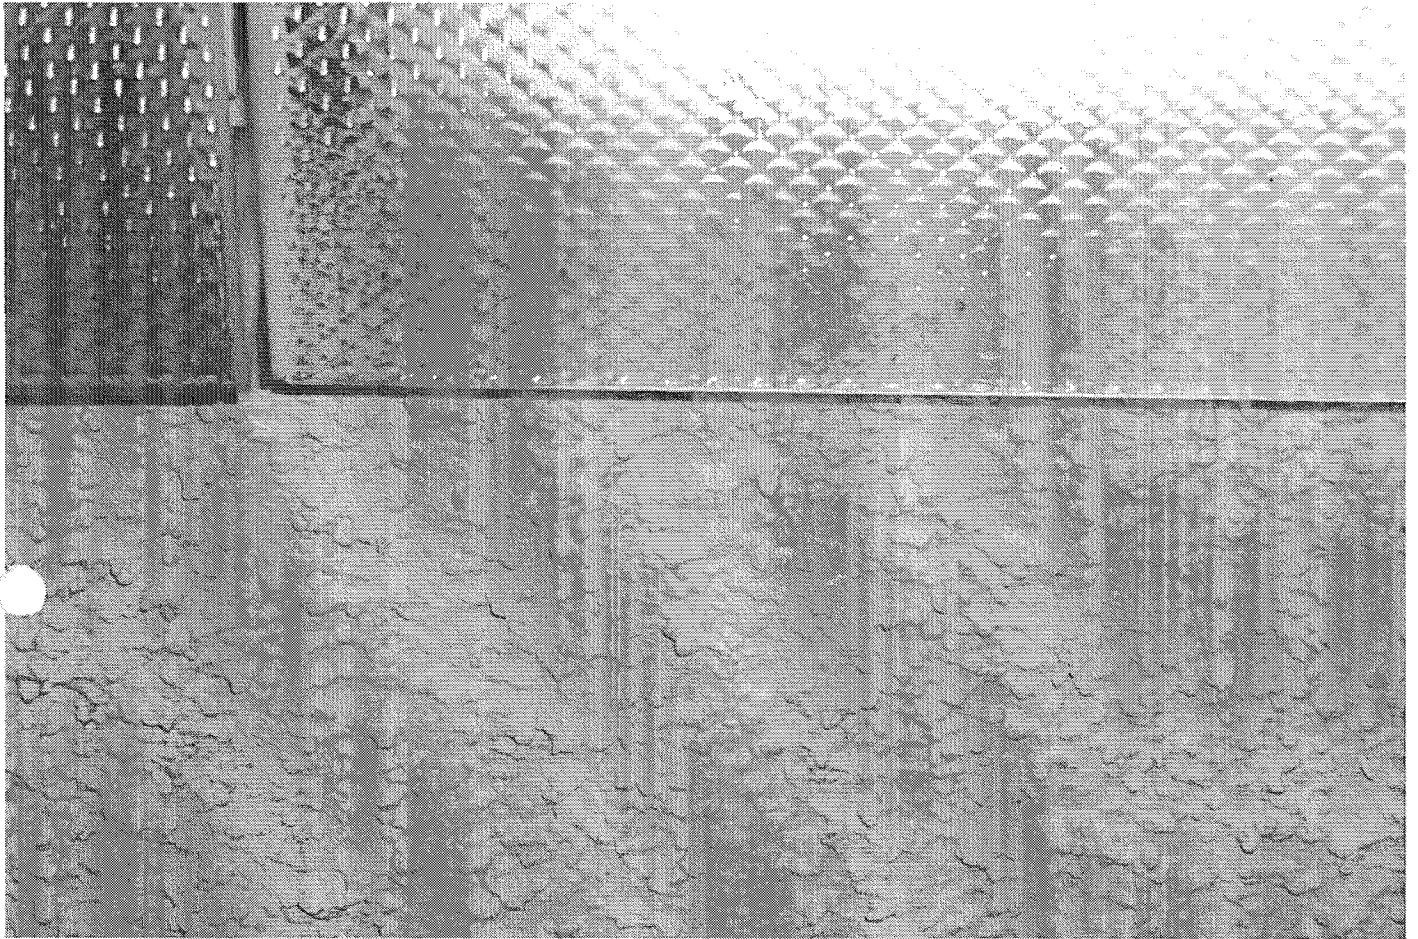
131. Back hallway at office area - Close-up of dislodged accoustical plaster debris inside the plastic lense of the light fixture
